HISTORIC AMERICAN BUILDINGS SURVEY
INVENTORY

2. NAME *Orrin Thompson Mansion*

DATE OR PERIOD *1832*
STYLE *Greek Revival*
ARCHITECT
BUILDER *Orrin Thompson*

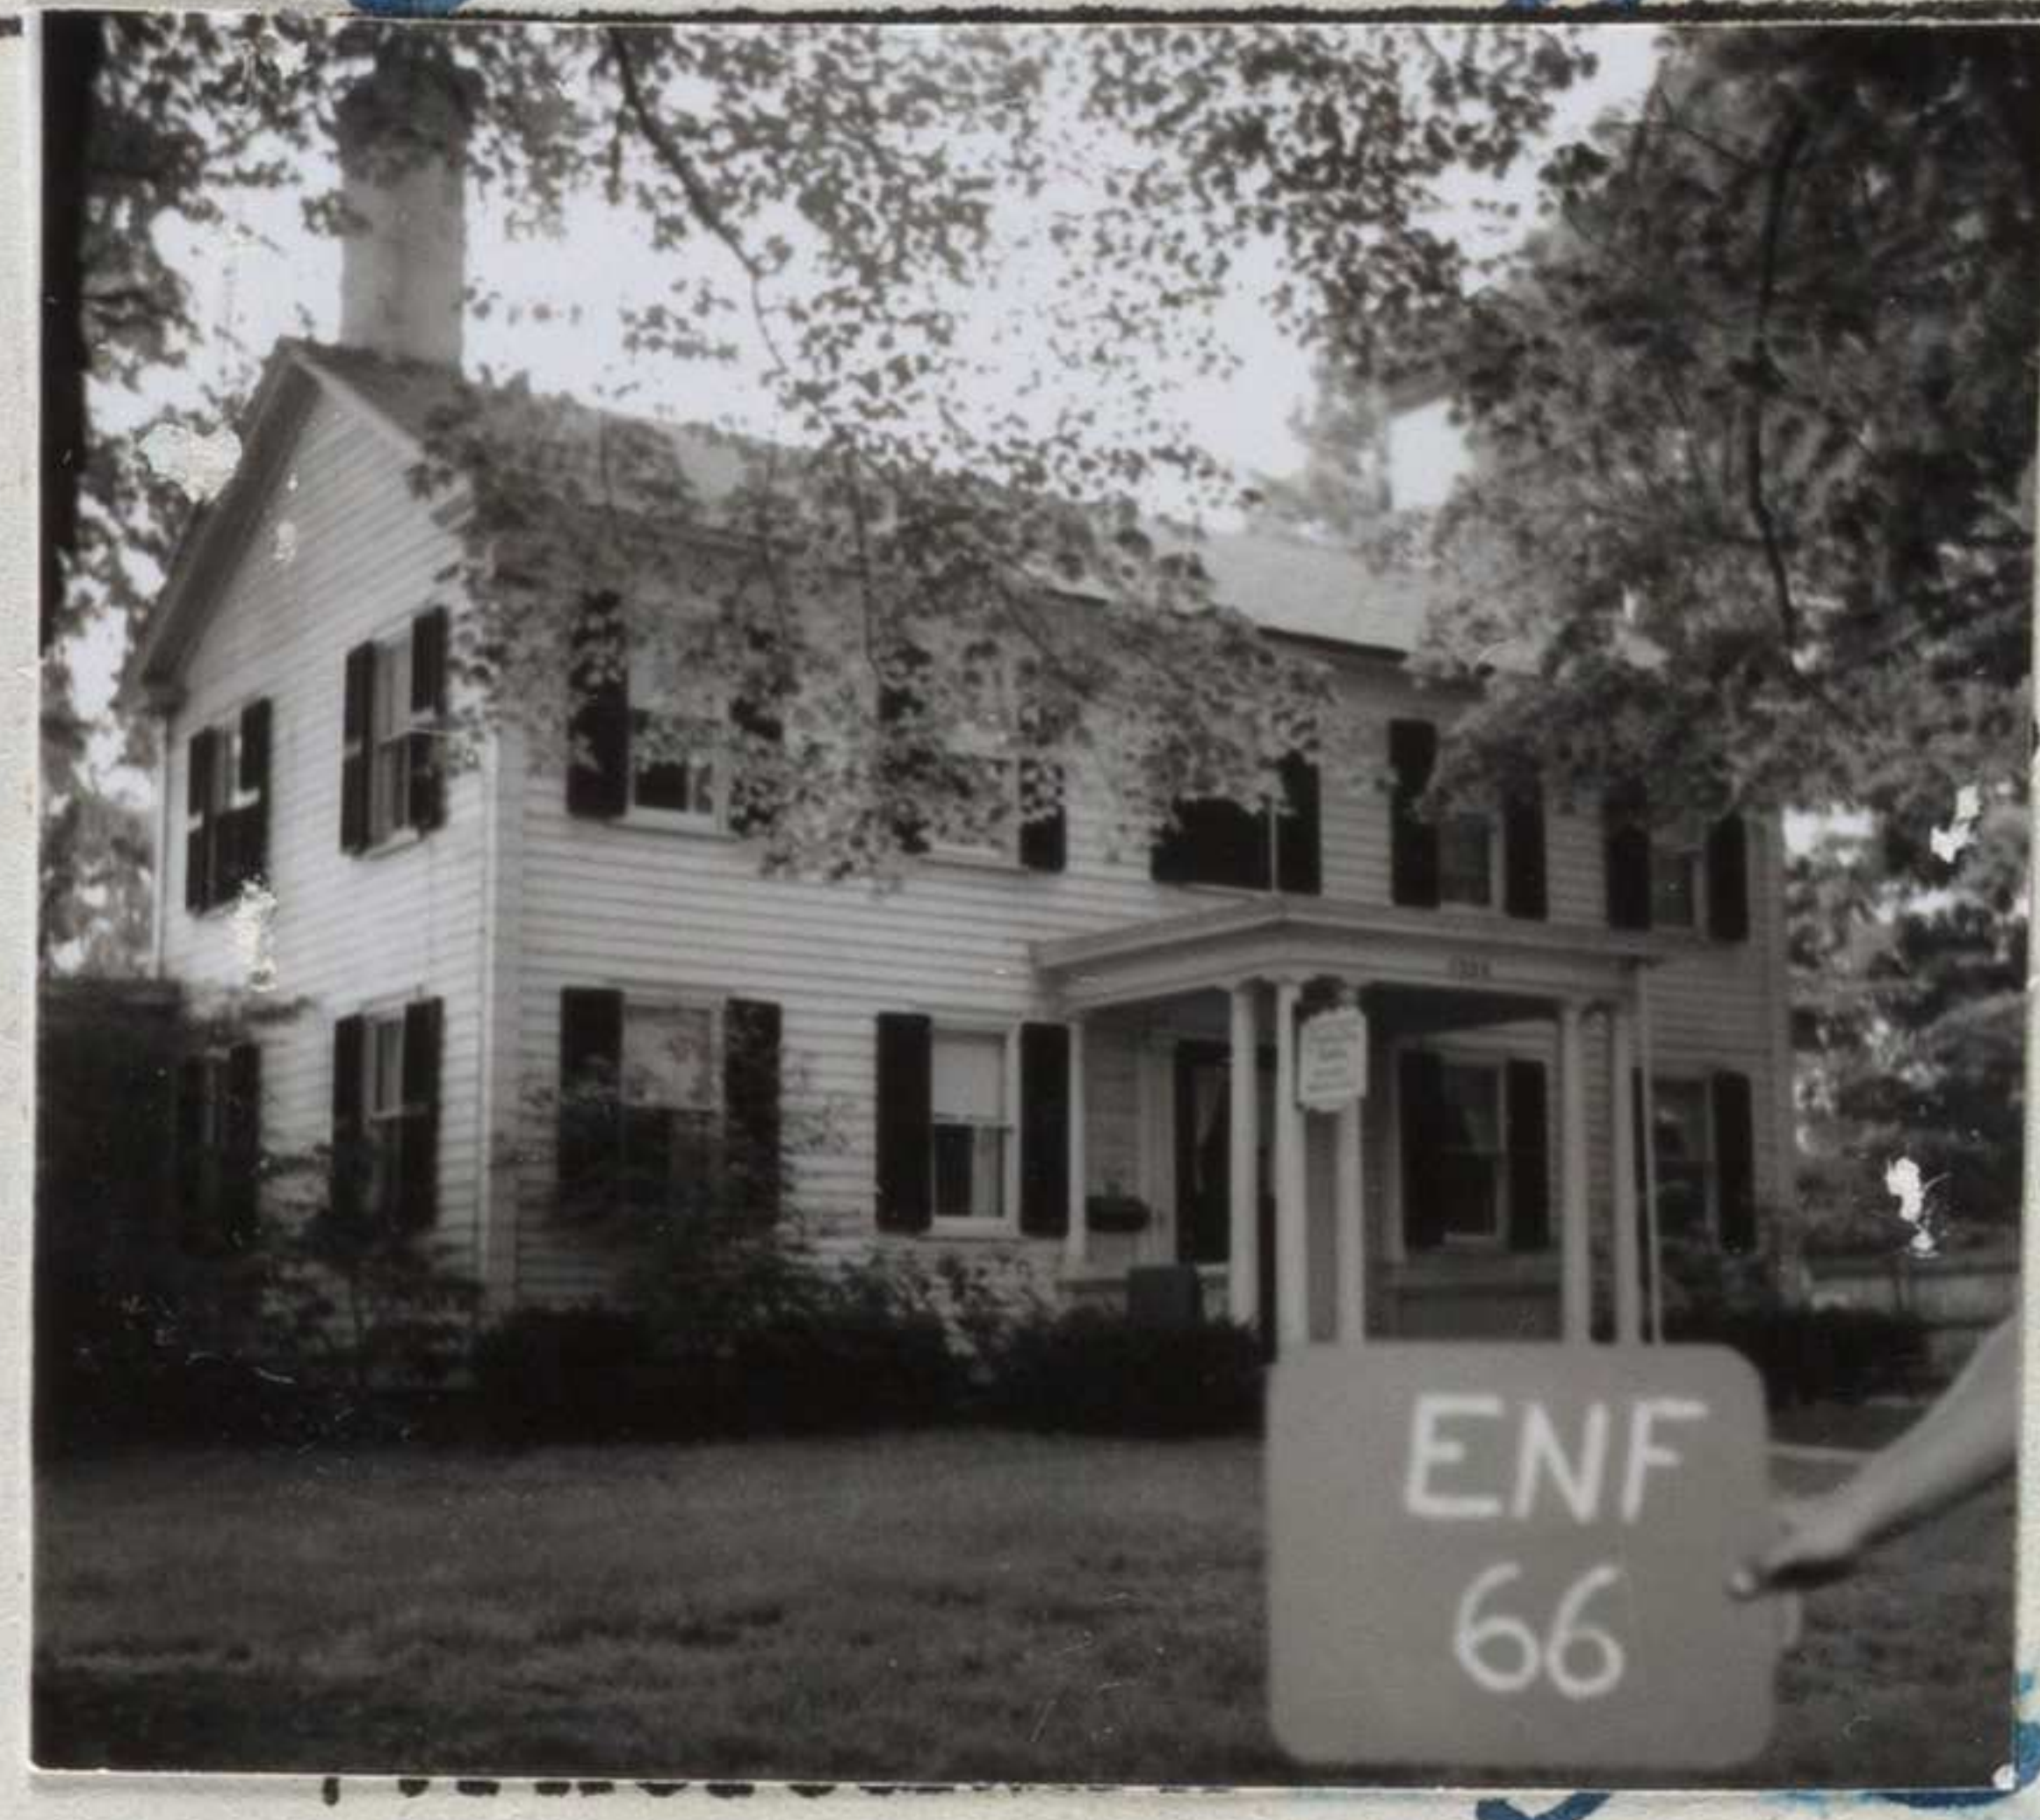
Peter Reynolds built three houses during the year 1821 to 1822, next to each other on Enfield Street #66, #67 and #69. This one is in five bays on a brick foundation with a shallow pitched roof. In common with its brothers, the house has little depth, and the chimneys are small and at the ends. The doorway has been largely changed with non original door windows. Original tapered paneled pilasters frame the doorway which is now unfortunately hidden under a new portico. The house is perhaps now better known by its occasional use: Enfield Country Day, a nursery school.

5. PHYSICAL CONDITION OF STRUCTURE	Endangered <i>No</i> Interior <i>fair</i> Exterior <i>fair</i>
------------------------------------	--

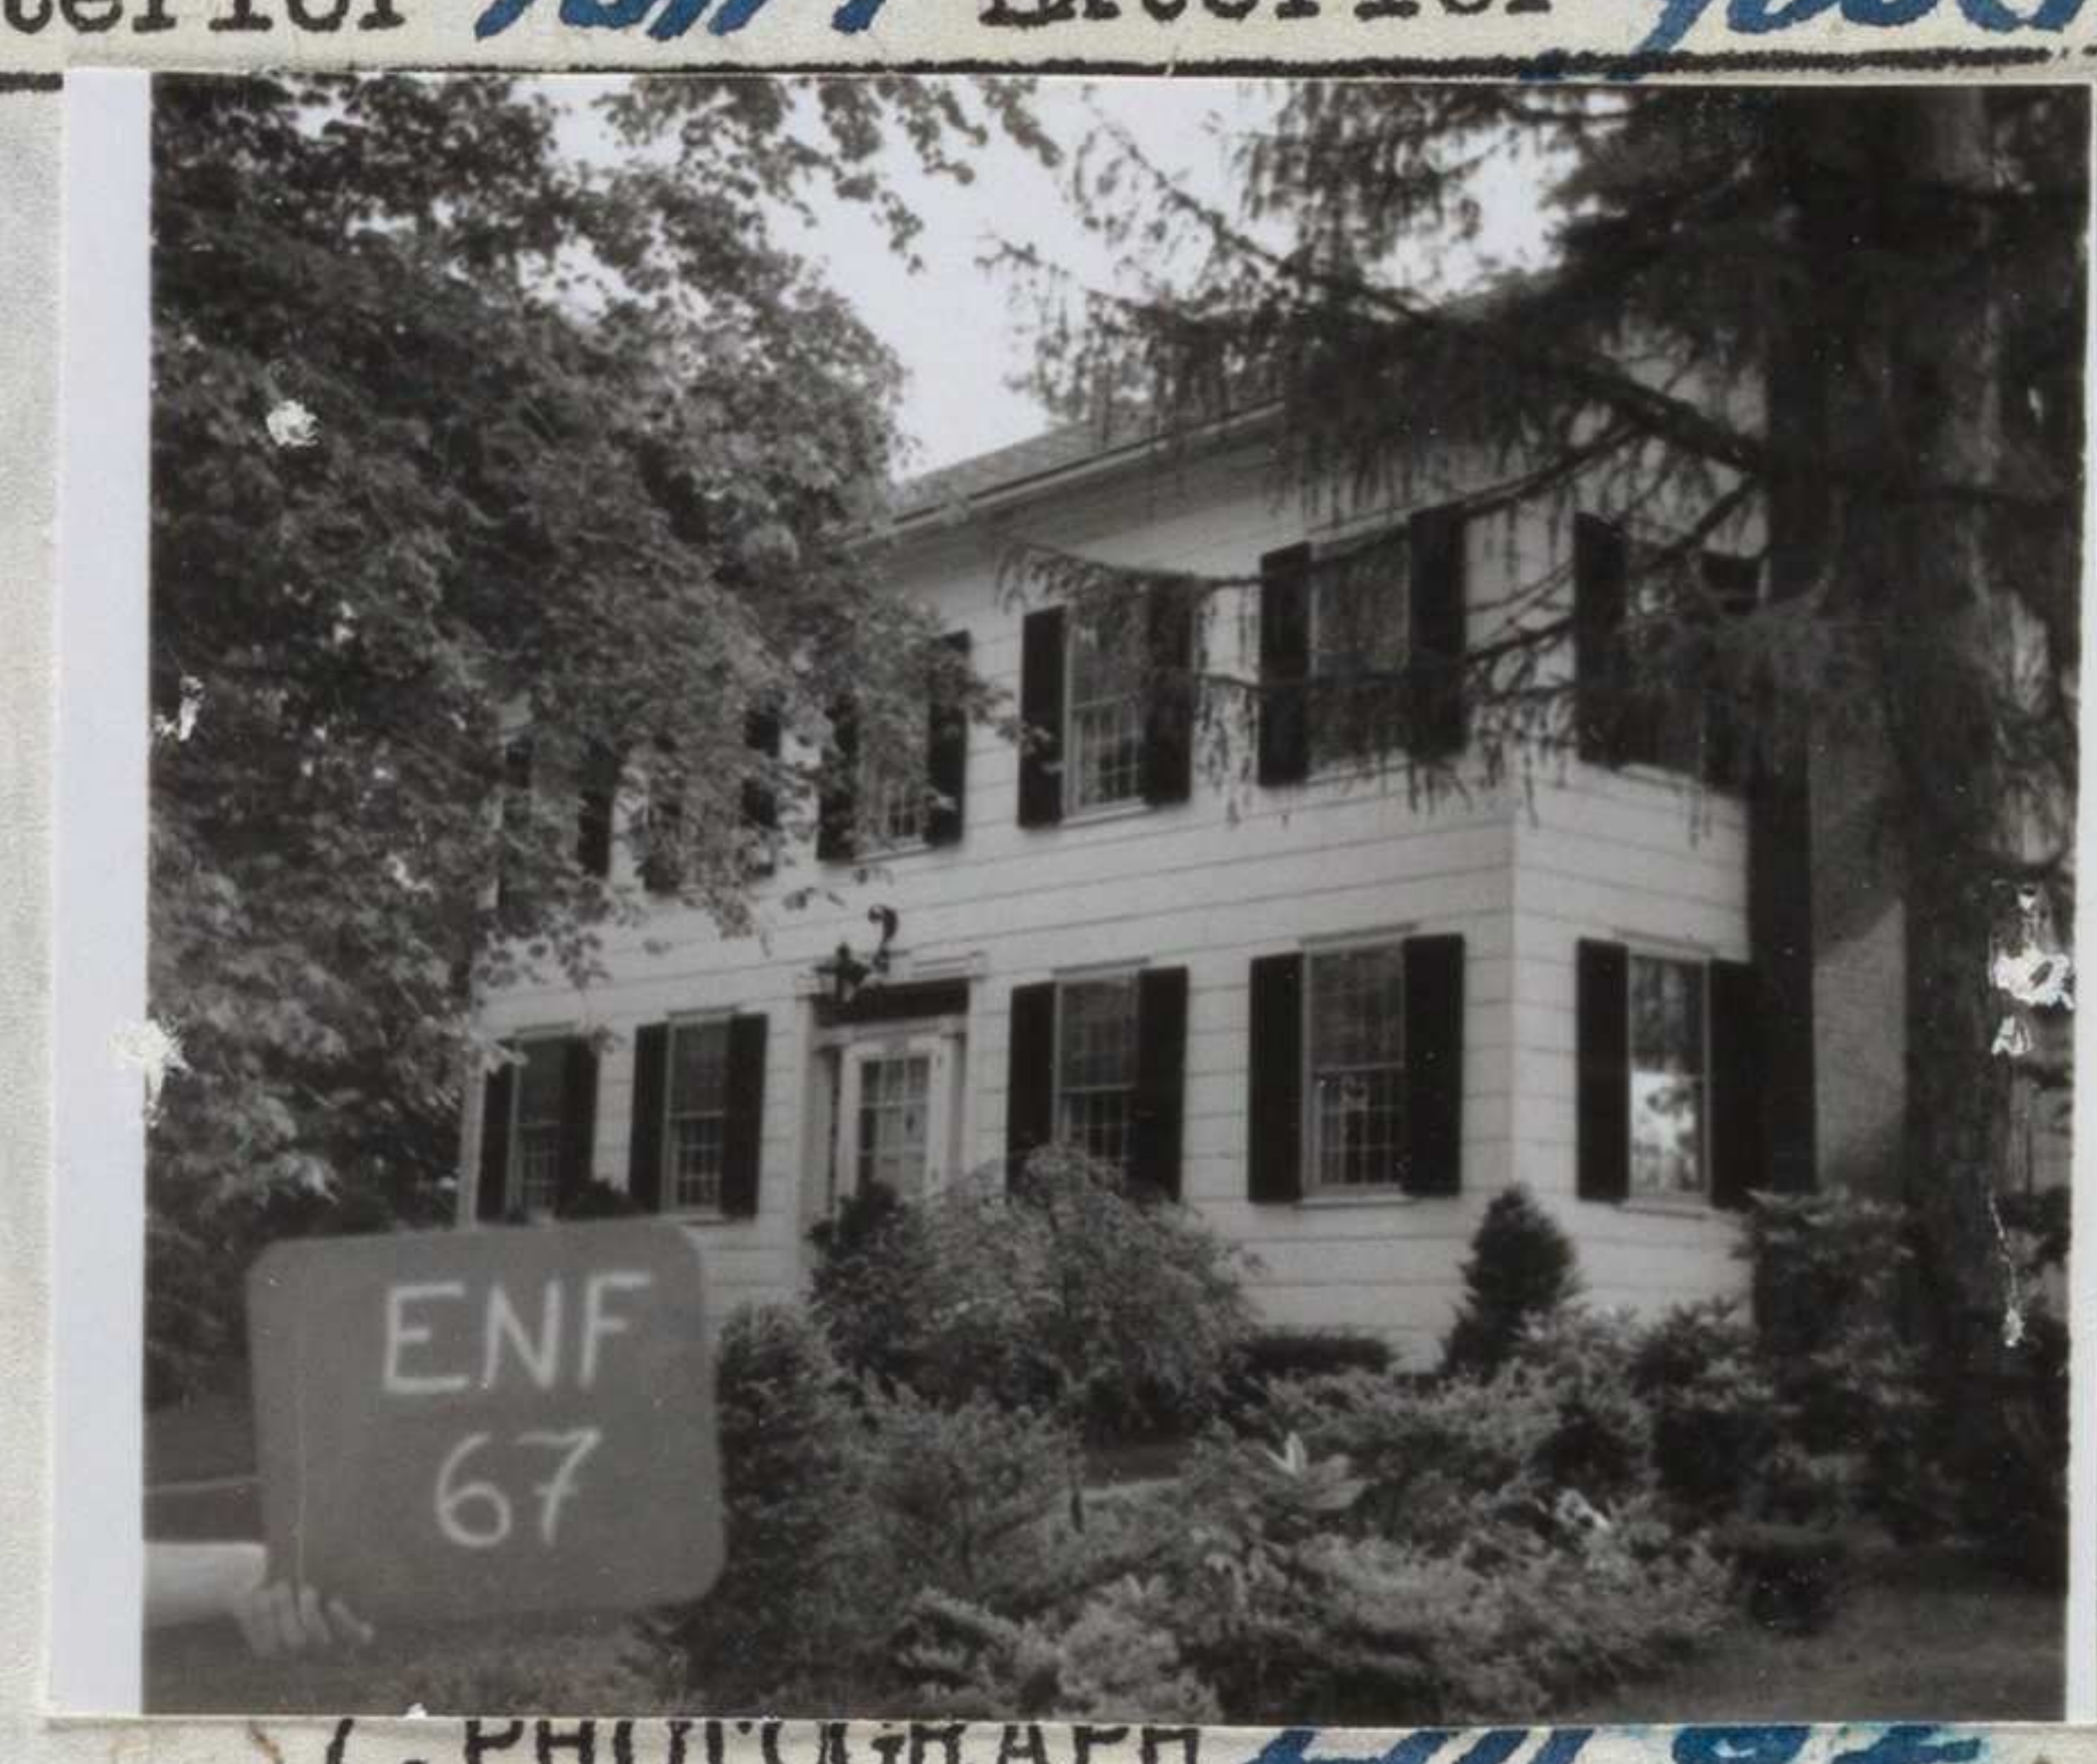
<p>1. STATE <i>CC</i> COUNTY <i>Hartford</i> TOWN <i>Enfield</i> VICINITY STREET NO. <i>1242 Enfield Street</i> ORIGINAL OWNER <i>Peter Reynolds</i> ORIGINAL USE <i>Residence</i> PRESENT OWNER <i>?</i> PRESENT USE <i>Residence</i> WALL CONSTRUCTION <i>clapboard</i> NO. OF STORIES <i>2</i></p>		<p>HISTORIC AMERICAN BUILDINGS SURVEY INVENTORY</p> <p>2. NAME <i>Peter Reynolds House</i> DATE OR PERIOD <i>1822</i> STYLE <i>Federal</i> ARCHITECT BUILDER <i>Peter Reynolds</i></p> <p>3. FOR LIBRARY OF CONGRESS USE</p>	
<p>4. NOTABLE FEATURES, HISTORICAL SIGNIFICANCE AND DESCRIPTION</p> <p><i>This second Reynolds house is also in the form of 5 bays, brick foundation, shallow pitched roof, double end chimneys (one of which is not original being exposed along the north side of the house. The windows are of 12/12 panes which might well be original. The doorway is the buildings finest feature. It is a late Federal-Early Revival affair with beautiful patterned lead work.</i></p>

<p>5. PHYSICAL CONDITION OF STRUCTURE</p> <p><i>Endangered No Interior fair? Exterior good</i></p>		<p>6. LOCATION MAP (Plan Optional)</p>

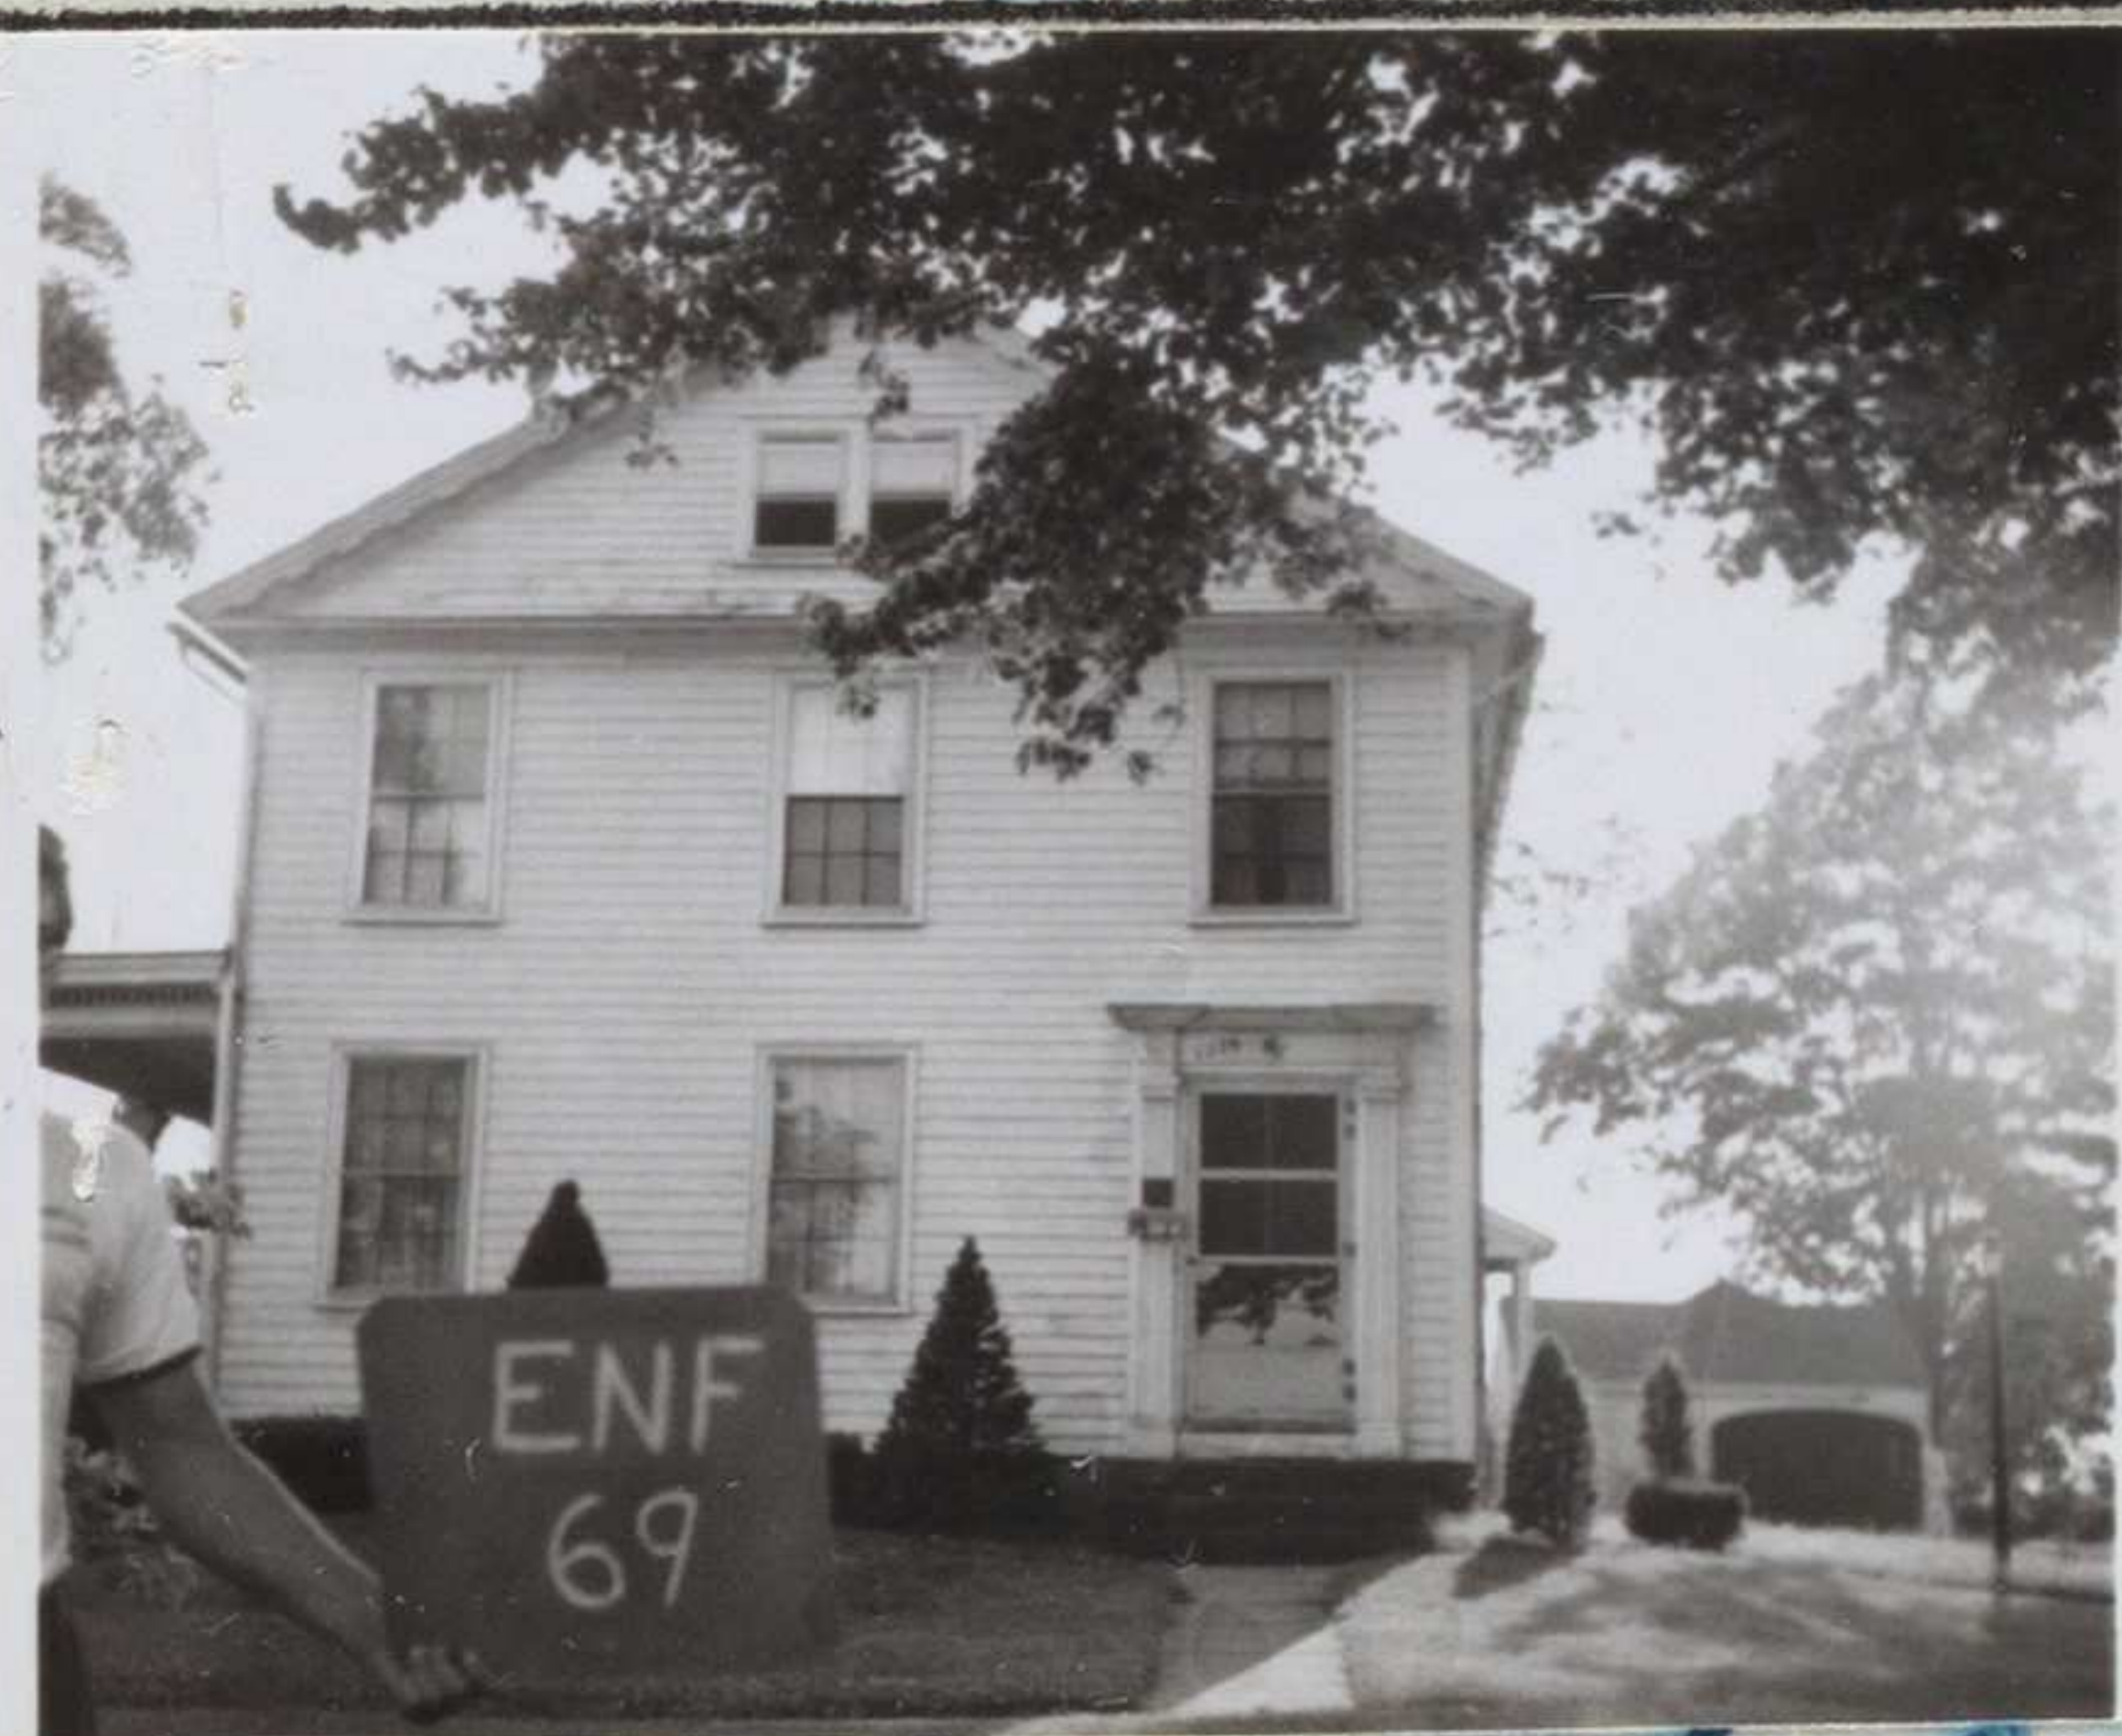
7. PHOTOGRAPH *Enf 69*

According to Mr. Angelica, the present owner the house was long owned by a Dr. Barney. It also belonged once to a Ct Representative to Washington. Like its neighbors it is distinguished by a shallow roof, accentuated pediment, and three bay facade, but the detail work is more interesting. The doorway is the same design as houses #65 and the Post Office, and although now largely removed the eaves were originally enhanced by dentil work with incised guttae. A rectangular pedimental window is a recent replacement of the original semi circular variety. Built on a brownstone foundation the house is extremely deep with a 1870 vintage porch to the South. The original carriage house is to the rear with a segmental topped door.

Endangered *No* Interior *fair* Exterior *good*

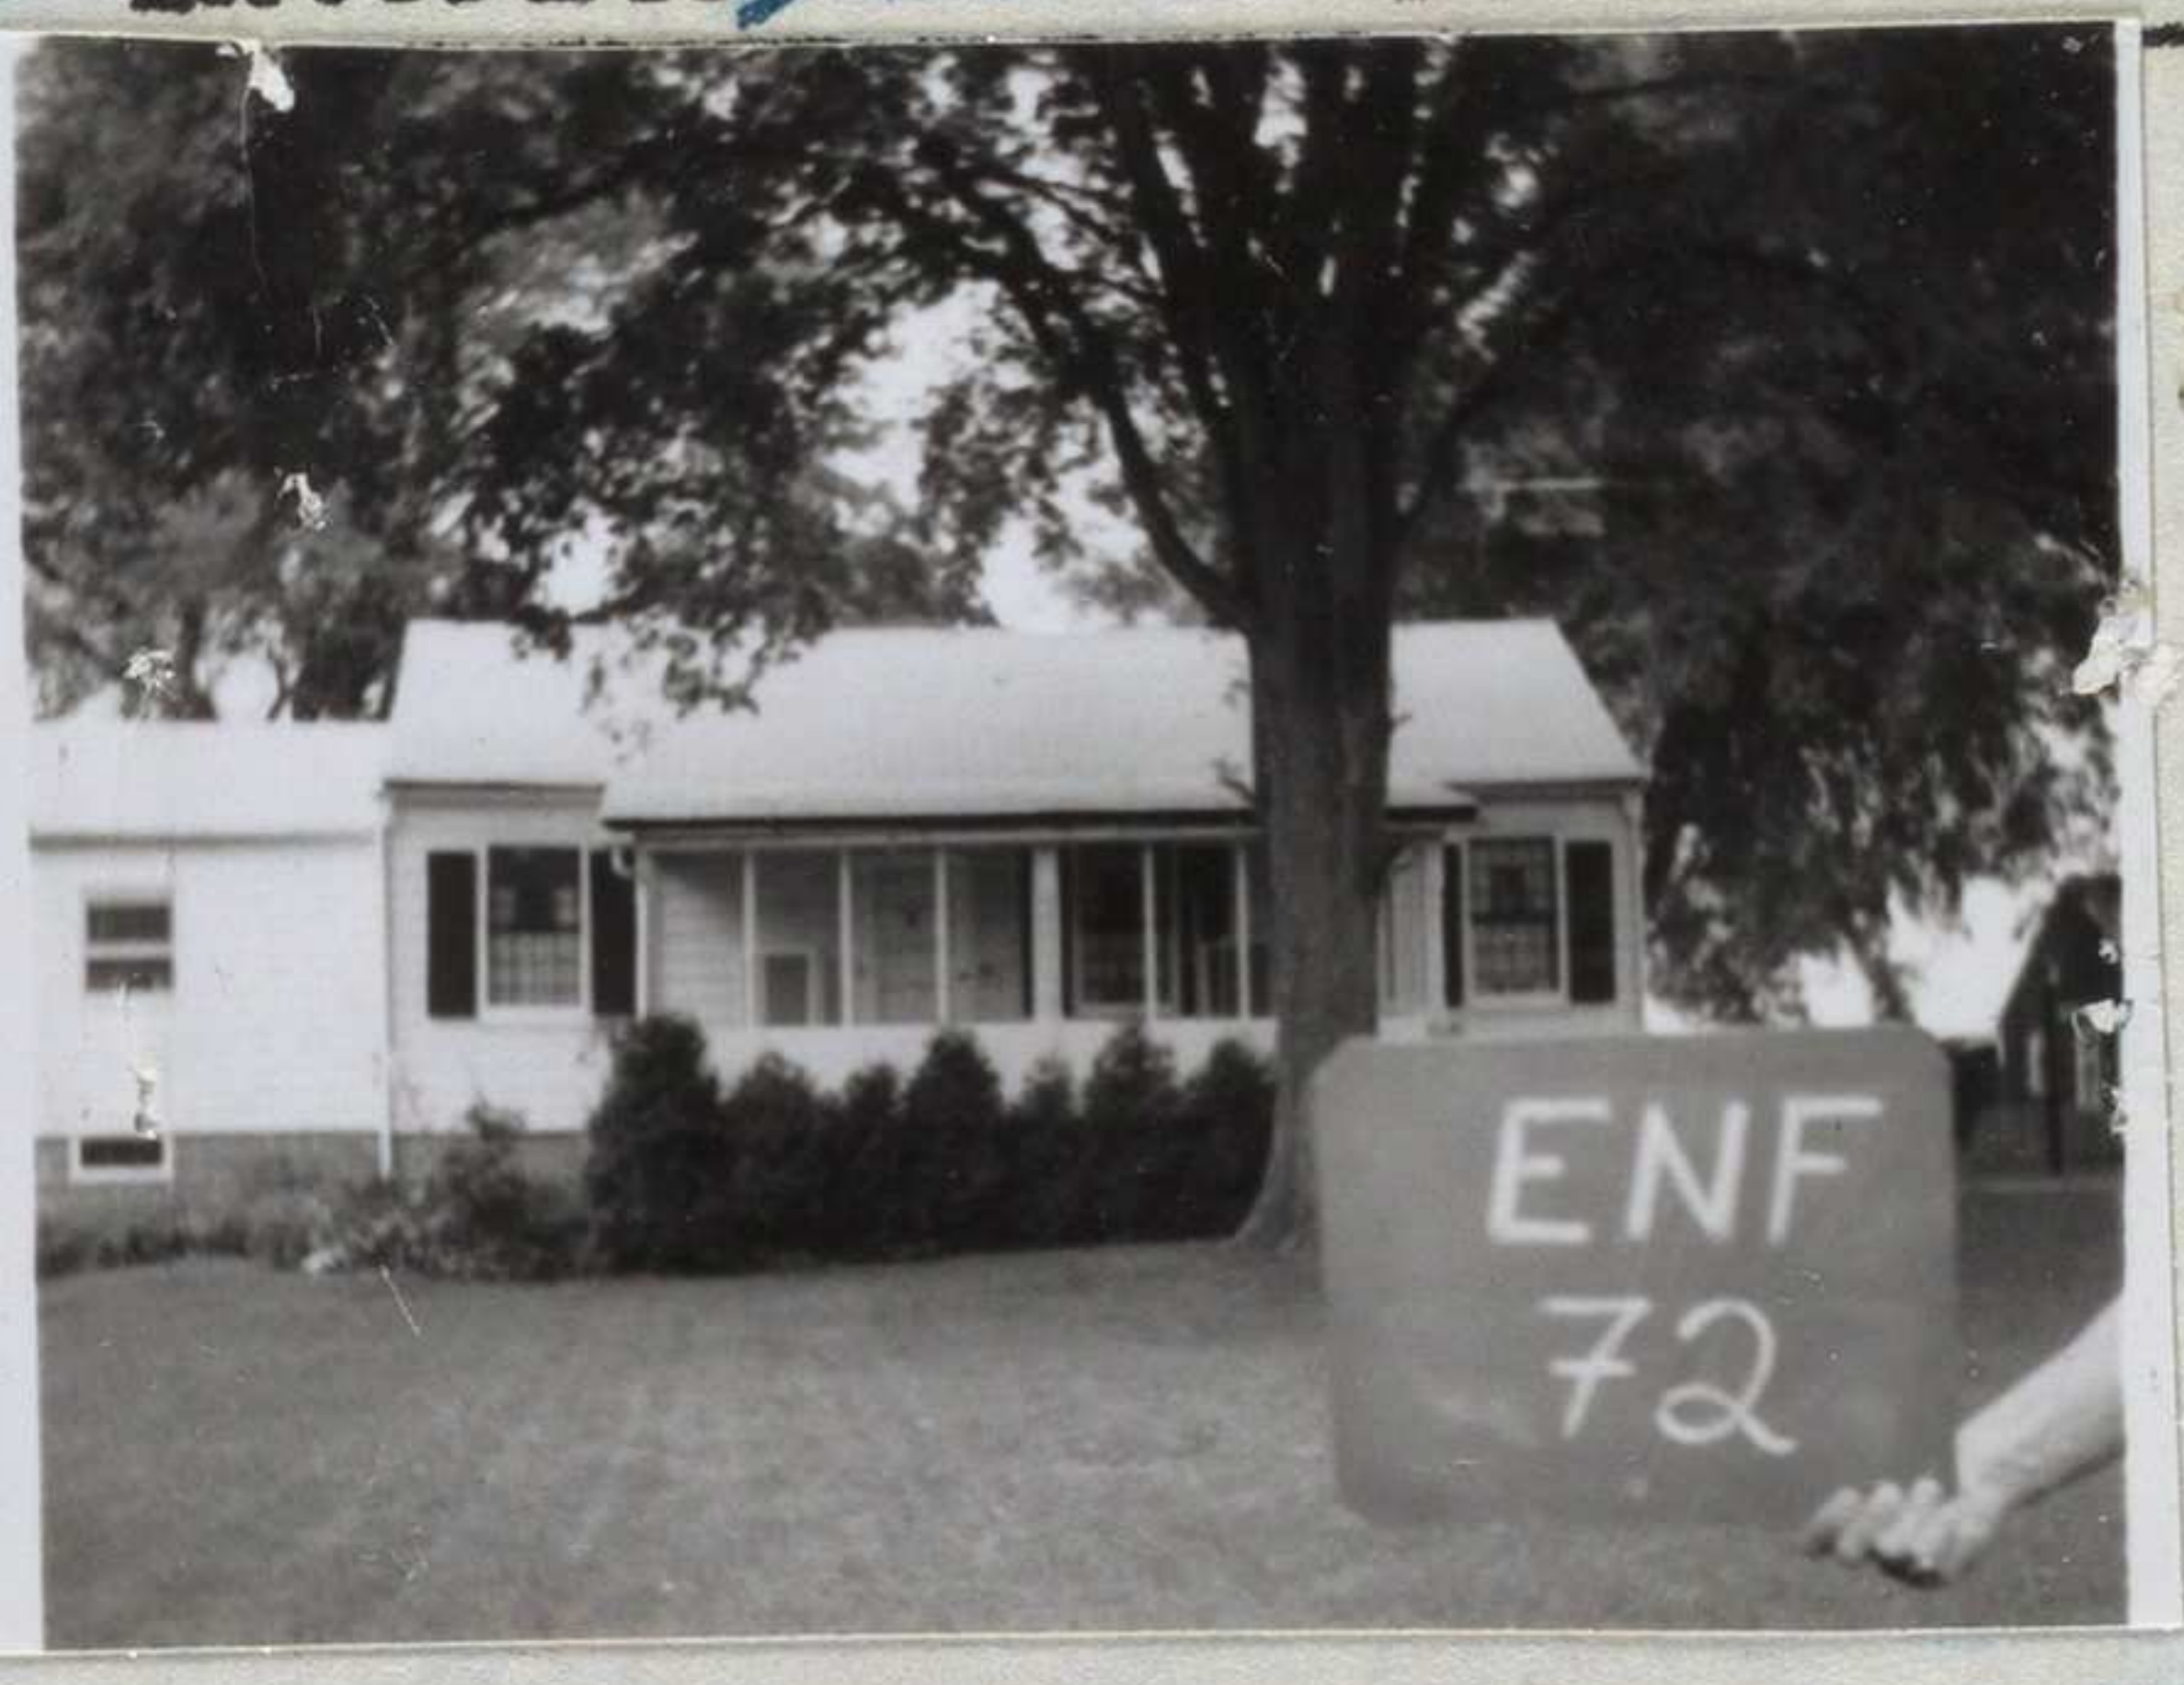
6. LOCATION MAP (Plan Optional)		7. PHOTOGRAPH <i>Enf 72</i>

2. NAME DATE OR PERIOD <i>pre 1750</i> STYLE <i>Colonial</i> ARCHITECT BUILDER	
		3. FOR LIBRARY OF CONGRESS USE	
4. NOTABLE FEATURES, HISTORICAL SIGNIFICANCE AND DESCRIPTION		OPEN TO PUBLIC <i>No</i>	
<p><i>Due to its brick foundation, I can't help wondering whether this house may not have been moved. It appears to be very early, perhaps an example of one of Enfield's first houses but it is difficult to be sure. The single story story dwelling is 4 bays long but rather lacking depth. The roof is shallow pitched, and a full length lean-to extends along the rear. The windows are 12/12, the roof slate. A porch in front and wing to the south have been added and the chimney is new</i></p>

5. PHYSICAL CONDITION OF STRUCTURE		Endangered <i>No</i> , Interior <i>fair?</i> Exterior <i>fair</i>

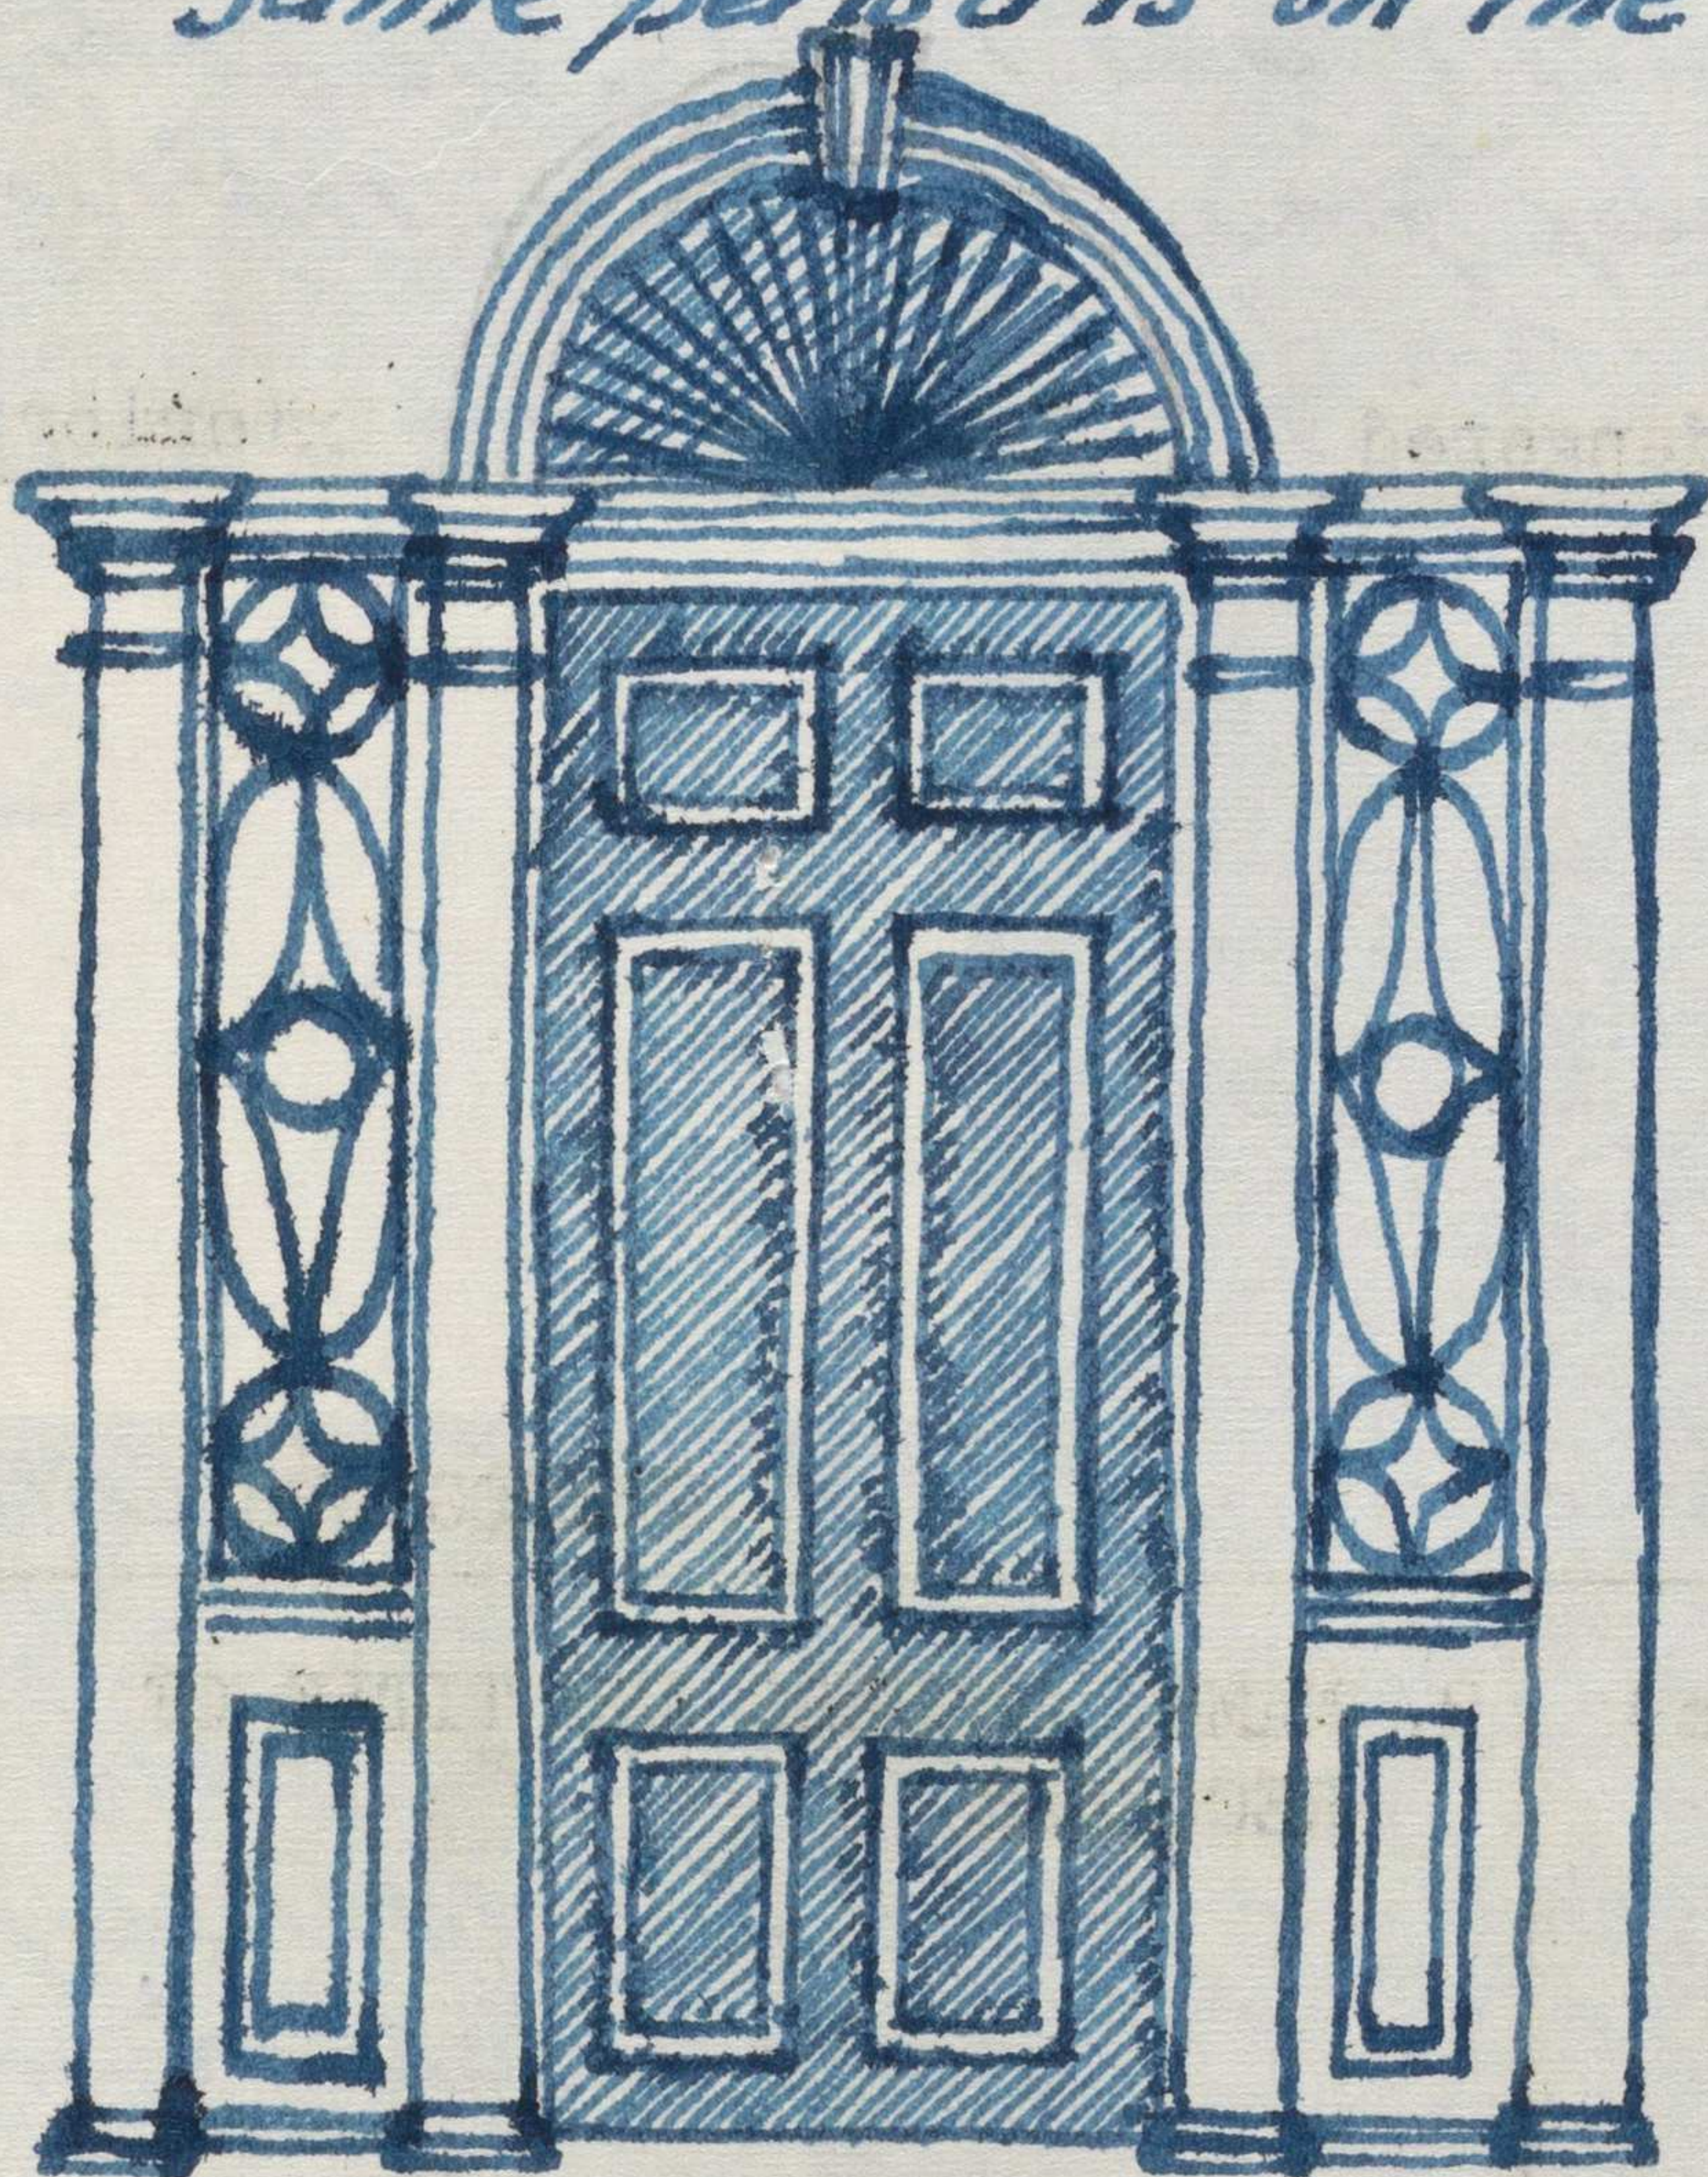
doorway

the large single upper floor. It was in this room that Mr. Sheldon underwent much of his primary schooling. The lower rooms were originally used as conference rooms. The house is five bays wide on its new brick foundation has a fairly shallow pitched roof. There are side chimneys, as would be expected for a building with a full length room. The shuttered windows are in 9/9 panes, the only such arrangement in town. The moldings around these windows is very fine. The pediments at either side are plain boarded and ornamented with fan/shutters and this motif is repeated in the semicircular transom over the door. This feature is encircled with fine molding and keystone. To either side of the door are fine leaded sidelights enclosed in colonettes and pilasters. An unfortunate 1920's vintage canopy encloses this fine doorway. A porch of the same period is on the south side of the house.
